# RESIDENTIAL LOUNGE AREA LEAK DETECTION

## PROJECT OVERVIEW

- Australian Waterproofing Consultants were engaged to investigate the likely cause of water ingress to a Bayside residence.
- Through non destructive visual inspection along with isolated water testing of the water-damaged areas, the main source of water ingress was identified at a discontinuity at a balcony stonewall joint.
- Developed two options to assist resolving the water ingress for the client to review.

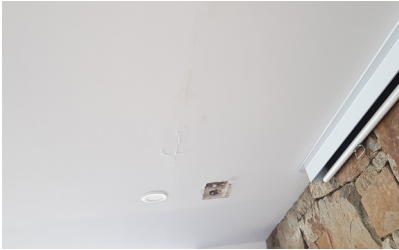
Areas showing where damage to ceiling plaster and redundant light fitting has occurred.

AWC performed a non-destructive visual inspection of the water-damaged areas along with isolated water testing, moisture meter testing, and thermal imaging. There was damage to the ceiling below the balcony with the plasterboard staining and paint blistering.

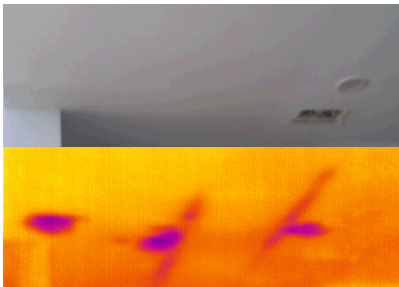
Thermal imaging (bottom) indicating areas containing water and their corresponding location on the ceiling photograph (top).

An isolated water test survey was conducted across the wall with thermal imaging carried out in the living room below to determine if there was a breach at the stonewall. When there is water present in an enclosed area, that area will become cooler compared to its surroundings and this can be detected by AWC's thermal imaging. Prior to our testing, the ceiling of the first-floor lounge area was a uniform temperature, which was not the case after testing.

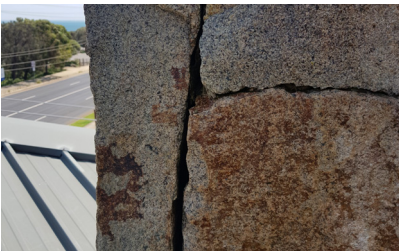
Stonework has unfilled joints, this allows water which strikes the stonewall during rain events to percolate to the back of the stone to the mortar/ adhesive bed. This water is able to track behind the stonework until it meets a breach or other discontinuity.

One side of the balcony was enclosed by a stonewall. AWC noted the joints in the stonework were not fully grouted.

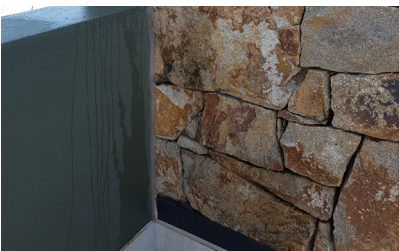
Area that has been isolated and is likely the primary area of water entry to the ceiling below.

AWC found that the main source of water ingress into the ceiling of the lounge area was from a discontinuity in the stonewall at the balcony parapet wall to stonewall junction. This is most likely due to a breach in the waterproofing membrane where it junctions with the parapet wall, resulting in a poor connection and allowing water penetration.

AWC provided two options to help resolve the water ingress depending on the client's preference. One, use a sealant to provide a seal at the indicated breach point. Although this would stop the water on its current path, it would likely be diverted to another part of the stonewall due to the number of open joints, and continued maintenance would be needed. Two, remove stone at the junction with the parapet wall for the full length from balcony to the top of the parapet wall. This would allow identification of the breach and a complete repair to the parapet wall to stonewall junctions with a compatible membrane product.
