CASE STUDY: LEAK INVESTIGATION ON A RESIDENTIAL APARTMENT COMPLEX - VICTORIA

AUSTRALIAN WATERPROOFING CONSULTANTS LEAD: Karl Wootton

Residential Apartment Complex - consists of two separate apartment buildings located on a single site. There is a large basement (parking and storage) which services both buildings with a common area green space, swimming pool and walkways separating the buildings. Both buildings are constructed predominantly with precast concrete, concrete block walls and lightweight claddings.

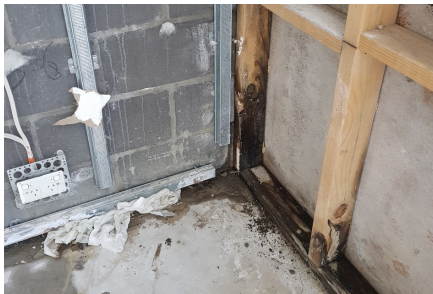
Water damage to timber framing from water travelling across floor slab.

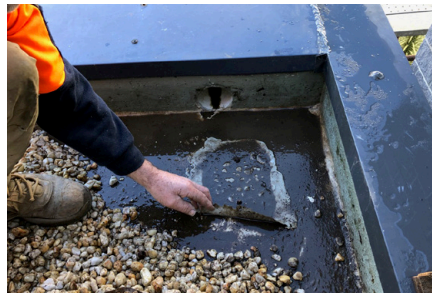
Blistering revealed on roof membrane.

- Staged replacement of the roof membranes over time as a scheduled maintenance plan to prioritise membranes that require immediate replacement and those that can be staged over time based on their current life cycle

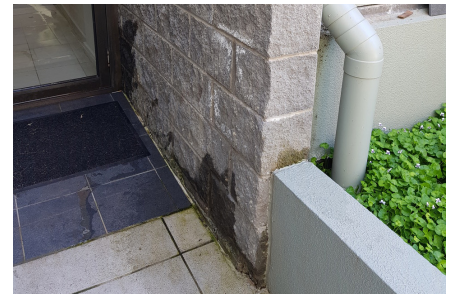
Water being drawn to internal floor slab due to poor building practices.
