RMIT MELBOURNE TERRACE REFURBISHMENT

PROJECT OVERVIEW

The refurbishment for RMIT Melbourne's terrace involved the rectification of a large leaking terrace area which formed part of a larger refurbishment project on the site.

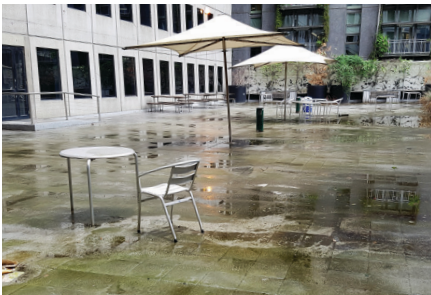
Existing liquid membrane applied over tiles prior to works commencing.

The existing terrace was covered with a structural slab, screed, waterproofing membrane and tiles when originally constructed. A liquid membrane was also applied to the top of the tiles in an attempt to remediate the terrace due to a number of leaks that had developed over time.

Previous remedial works failed to take into account the water/moisture entrapped below the tiles and as a consequence the membrane applied to the tiles failed to remain watertight due to the effects of thermally induced heat gain and movement, causing vapour blistering and the subsequent rupturing and tearing of the waterproof coating applied.

It should be noted this is not a failure of the coating, rather but a lack of understanding of the effects of retained moisture and its future impact on any applied coating.

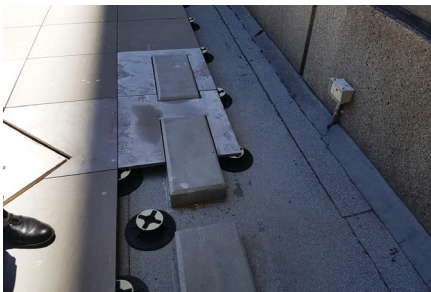
New waterproofing membrane with pedestals and pavers being installed.

After our investigation and consultation with the client, Australian Waterproofing Consultants recommended that a new sheet membrane be applied over the existing failed waterproof coating. This new sheet membrane was loose laid over the terrace and mechanically fastened with the sheet overlaps and perimeter details being fully bonded and finished with a liquid waterproof membrane that is compatible with the structure and sheet membrane used.

This method of installation allows for any moisture retained beneath the waterproof membrane to freely dissipate. Any build-up of vapor pressure would be relieved without affecting the integrity or watertightness of the new waterproof membrane installation.

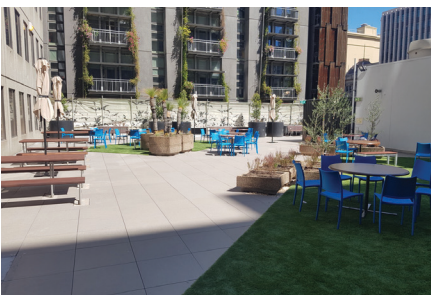
Finished installation featuring pavers and artificial turf on pedestals which can easily be lifted for maintenance inspection of the waterproof membrane and cleaning.

In order to protect the waterproof membrane pavers and artificial turf were set on pedestals to create an air gap between the waterproof membrane and wearing surface. This allows the free drainage of surface water and affords protection to the membrane. An added benefit to this method of installation is that the waterproof membrane can be easily inspected at any time.
